## **TEST & EVALUATION REPORT**

Screening Evaluation of Shingle Rejuvenator

Report For: NovaShield Inc.

Client: NovaShield Inc. Project No.: BBSS 01-02-01

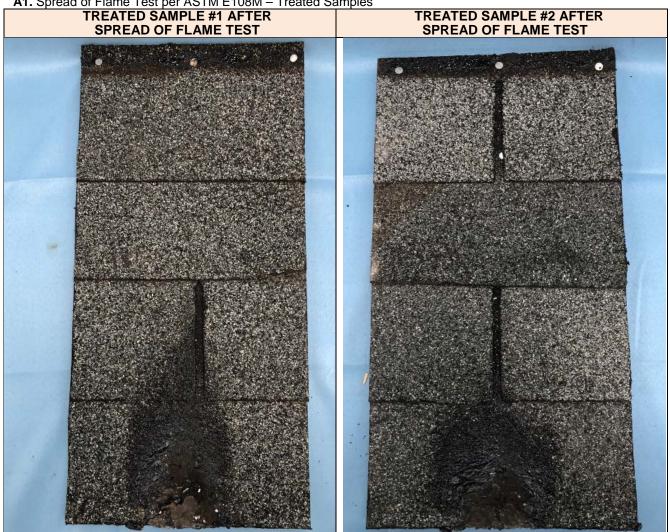
A1. Spread of Flame Test per ASTM E108M – Treated Samples

## **DISCUSSION:**

Spread of flame covered less surface area (a distinct benefit). This is worthy of further investigation.

- 1. Flexibility<sub>23°C</sub> was improved (Failure to pass).
- 2. Granular Adhesion was improved significantly from a granular loss of 1.11 g to a loss after treatment of 0.15 g, an 86% improvement.
- 3. Hail Impact was slightly improved after treatment. The improvement, 6.6%, was minimized by the type of shingle evaluated organic felt based. The data suggests Hail Impact would have a greater improvement on FG mat-based shingles.
- 4. Fire Resistance 'UL Speed of Flame:' The treated shingles exhibited a flame spread of 86 in² vs. the untreated shingles exhibiting a 144 in² spread. This was unexpected.

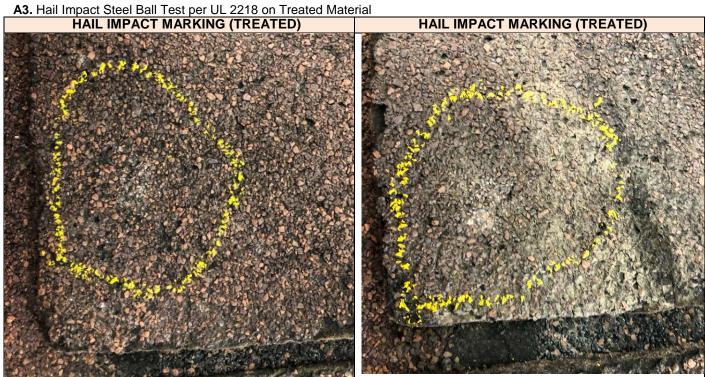
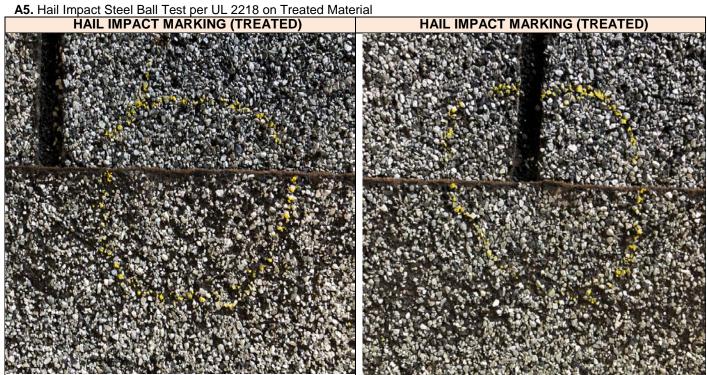
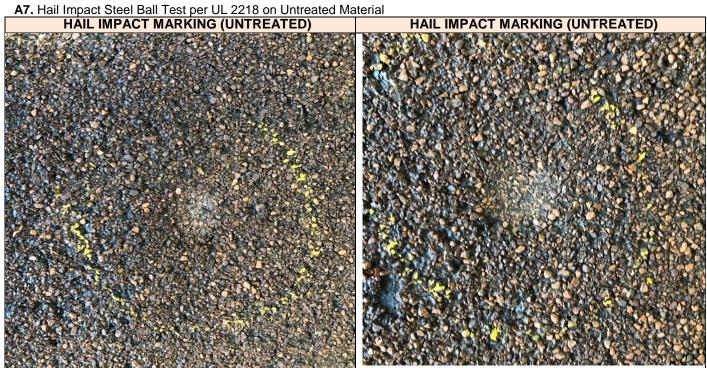
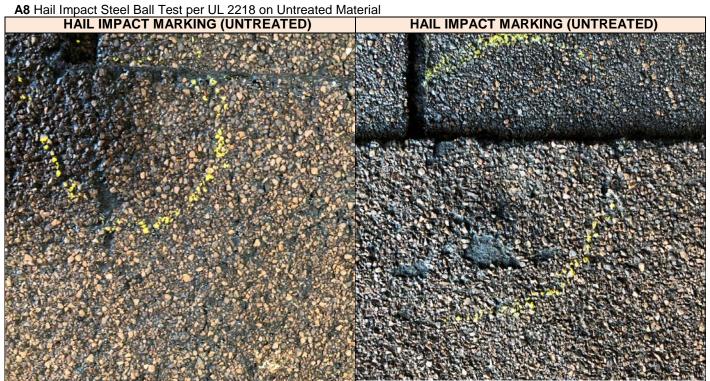
Because the test shingles were organic felt based, the criteria for Hail Impact Resistance; cracking, and damage to the shingle surface was not observed.

Consequently, we included photos exhibiting the results on the granular surface. The results were mixed primarily due to the severely aged conditions of the test shingles. However, the treatment appeared to re-adhere the granules, which reduced the surface damage some.
